Church of the Holy Saviour, Puxton

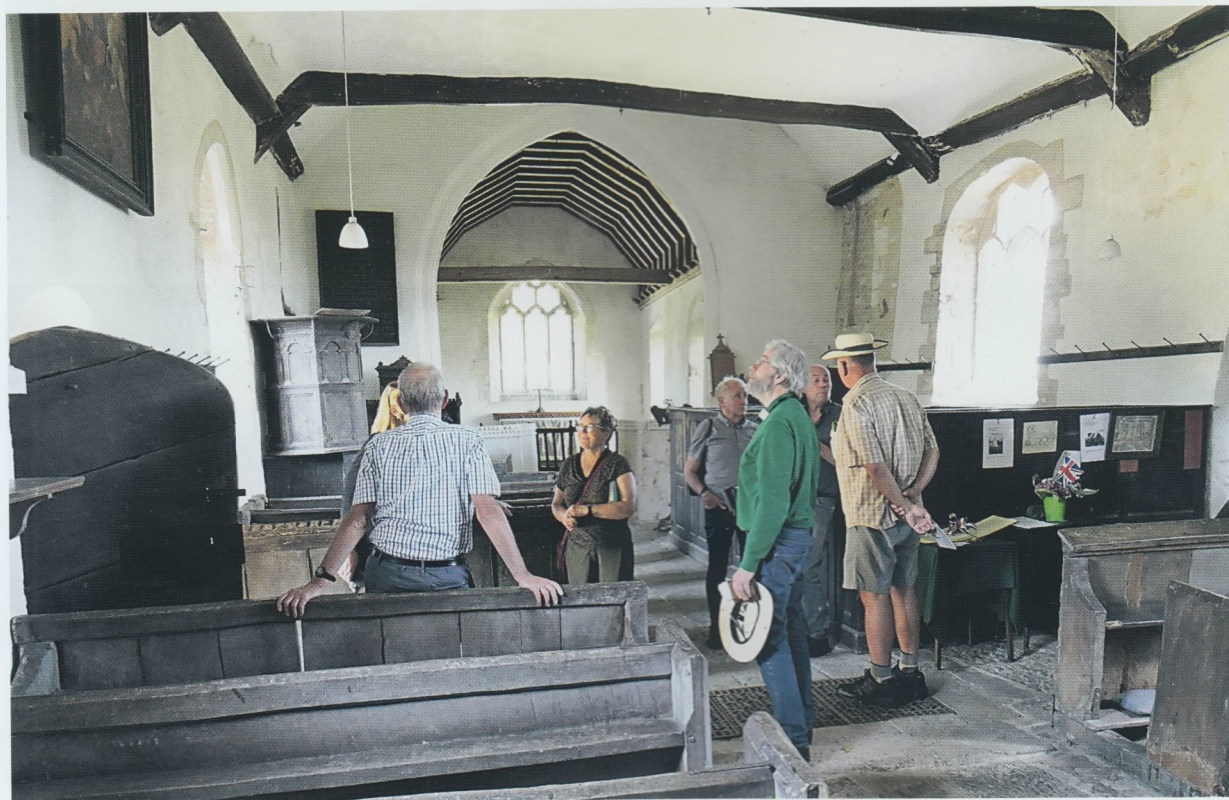
Church of the Holy Saviour, Puxton. Interior with people! Note the Jacobean pulpit and hourglass stand and the saw marks visible on the back of one of the benches. *Photo Linda Hall*

The seventeenth-century pulpit sits precariously on a simple base of vertical boards; it has the usual Jacobean arches in the upper panels and the book ledge is

supported on twisted iron brackets. Identical brackets support the iron hourglass holder in the reveal of the adjacent window. Near the pulpit is an unusual survival, the fragmentary remains of the rood loft left embedded in the wall when the structure was sawn off and removed. South of the chancel arch the clerk's desk, which goes with the pulpit, blocks the lower door to the rood loft stair; the upper doorway is blocked but still visible.

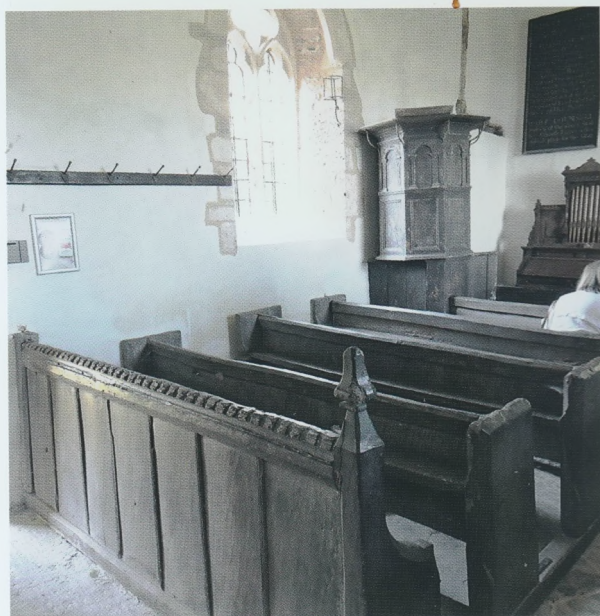
The back of the benches by the north door is decorated with a crenellated top rail and a simple finial. *Photo Linda Hall*

delightfully uneven, and the nave has a mixture of box pews and benches, the latter totally plain apart from the back of the one by the door, which has a crenellated top rail and a pleasing finial. Saw marks can be seen on the back boards of the benches and simple repairs have been effected a long time ago by the local blacksmith, using simple iron plates to reinforce the joints between bench end and back rail.

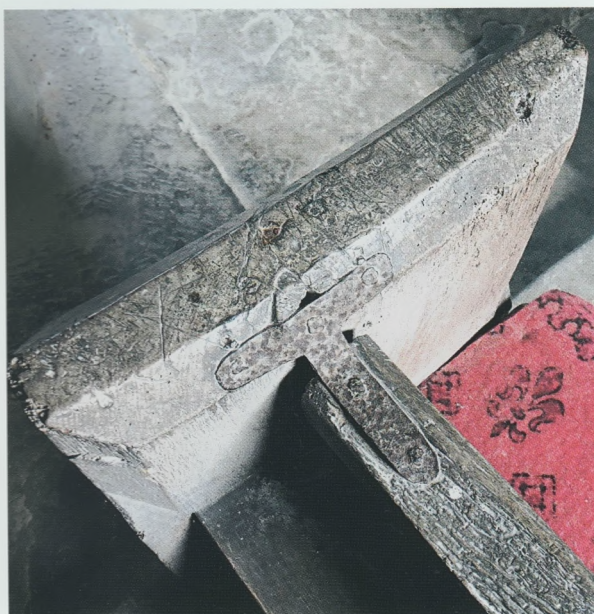
Simple blacksmith repair to a bench end. Note the incised crosses which may be apotropaic marks. *Photo Linda Hall*

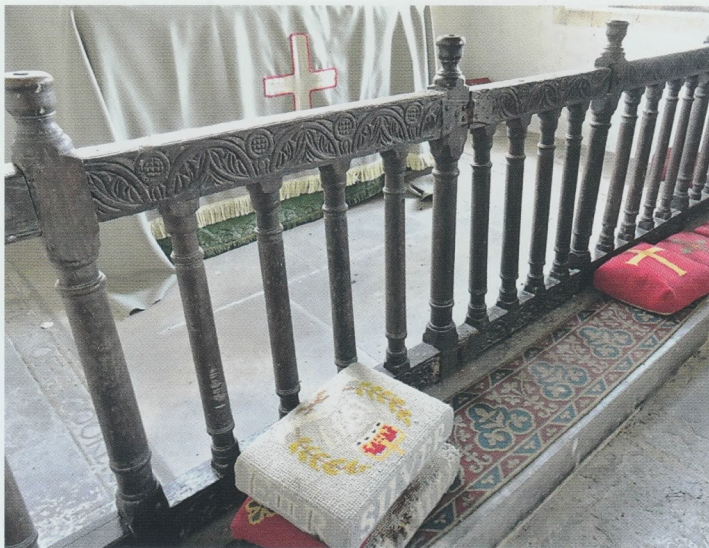
Seventeenth-century altar rails with simple turned balusters and finials and lunette carving along the rail. *Photo Linda Hall*

There is more seventeenth-century woodwork in the chancel, where the altar rails have simple turned balusters and finials; the lunette carving along the top rail is similar to the decoration on the fine local chest apparently abandoned in the base of the tower with assorted other items. The chest has seen better days,

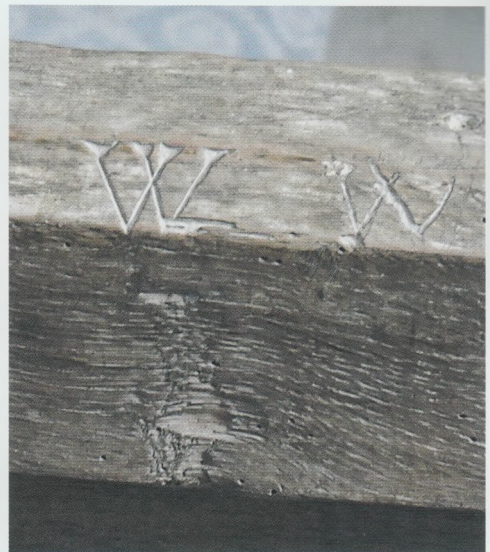
Two W's carved on a bench rail; apotropaic (Virgin of Virgins) or simply someone's initials? *Photo Linda Hall*

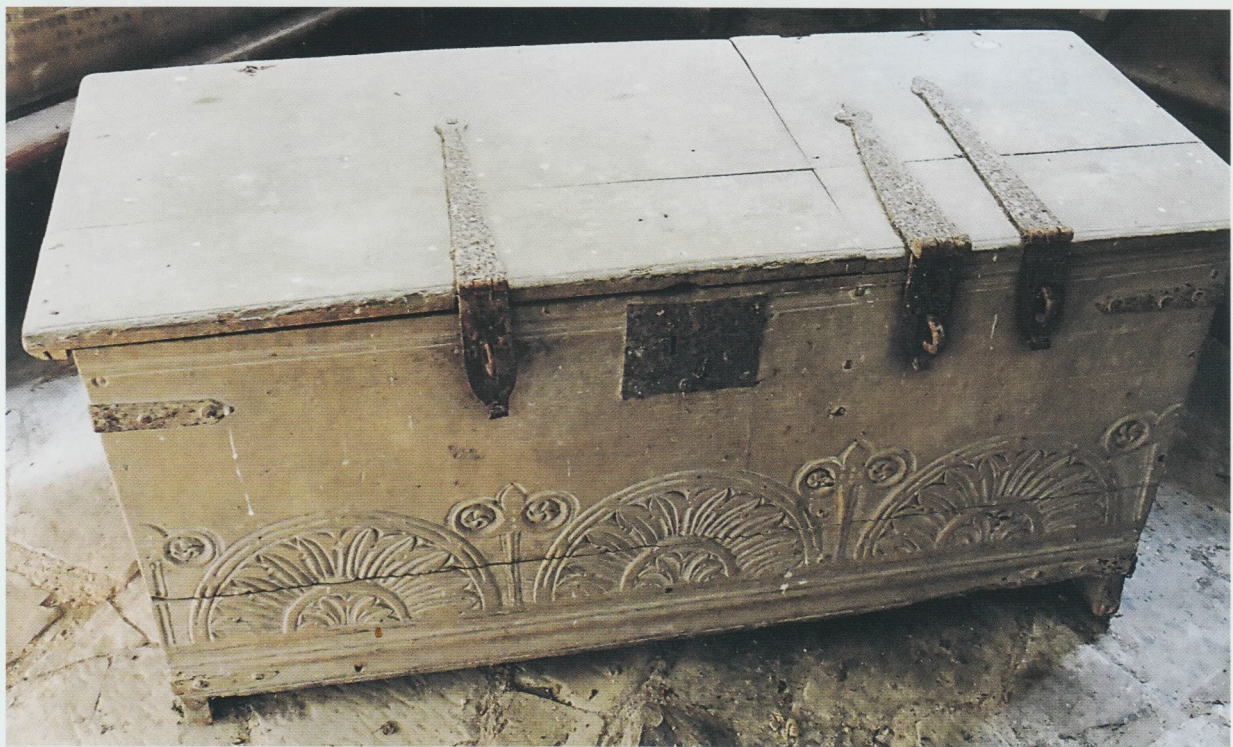
Fine seventeenth-century chest in the base of the tower, decorated with three large lunettes. *Photo Linda Hall*

with iron straps holding the ends to the front and back panels. The front panel has split through the carving, which consists of three large lunettes with stylised foliage between. There is a single plain lock plate, suggesting original use in a domestic context, but three large hinged straps were added to the lid, with hasps on the front panel, so that the vicar and churchwardens could each have a padlock key to provide the necessary security.
